# Challenges & Pragmatic Solutions for the Design and Construction of a 300-Acre CCR Landfill Located in the Southwestern US - A Case Study

An overview of the closure design of a 300-acre landfill and the unique design challenges posed will be presented. The project site is located in an arid region in the southwestern United States. Limited on-site soil borrow volume, stormwater (existing “flat” areas), vertical sandstone highwalls, landfill access during post-closure period, and site retirement requirements necessitated unique design solutions at the site. A unique solution was developed and implemented at the geomembrane termination at the vertical sandstone highwalls.

WOCA 2022 Conference, 19 May 2022

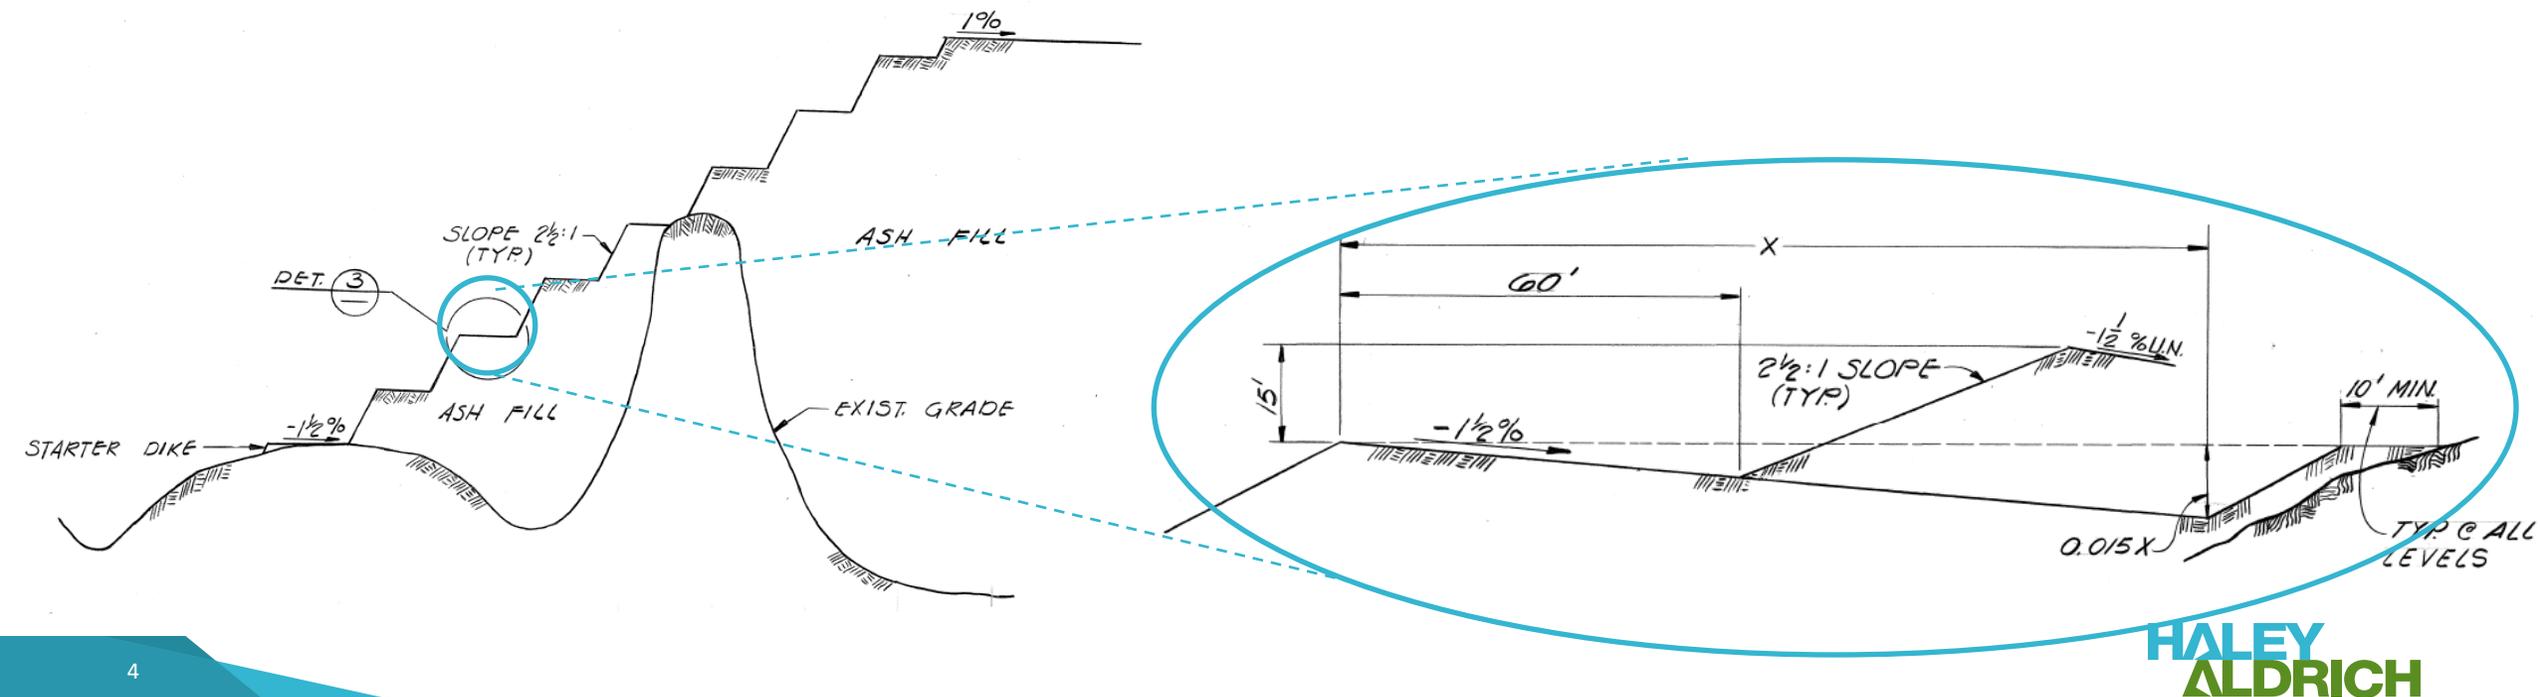
- Improper placement of material - 50-years of bottom ash, fly ash, and FGD placement without clear adherence to design

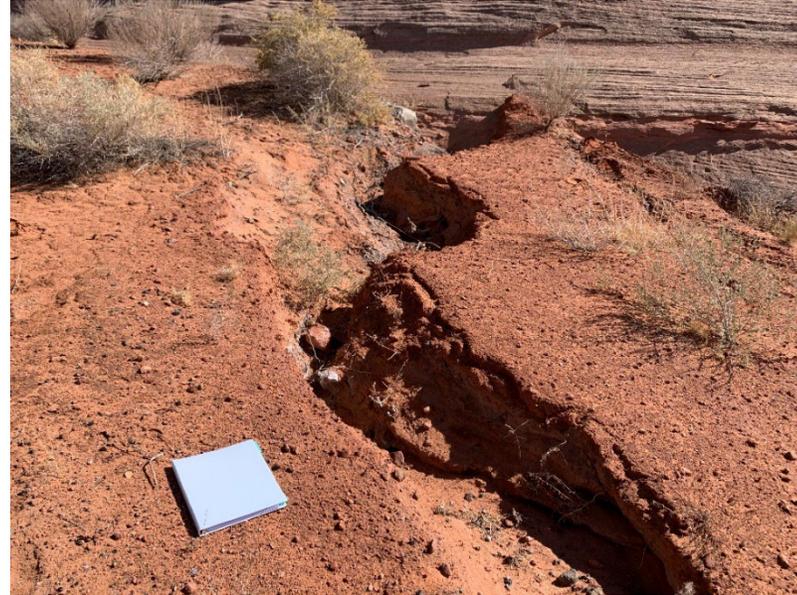
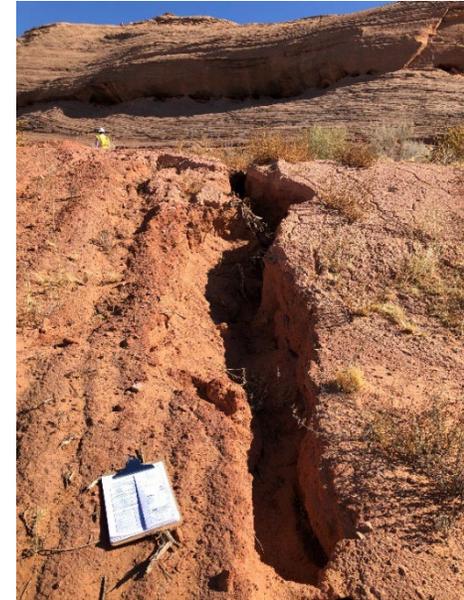
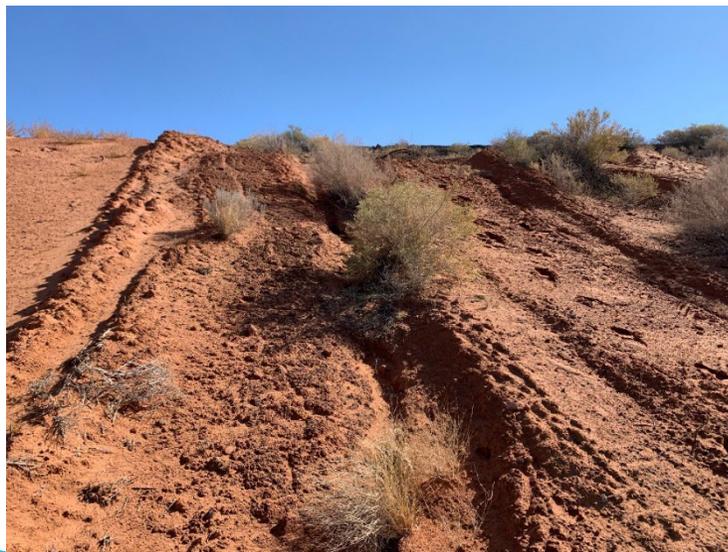
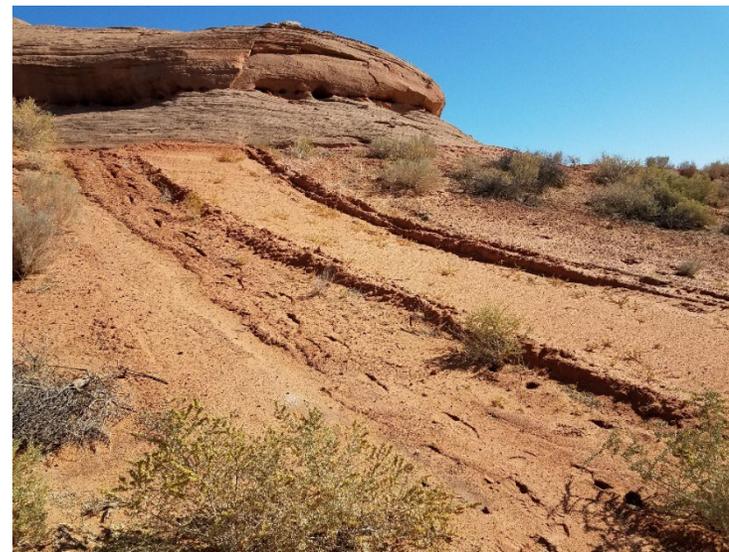
- Areas within landfill that have received interim cover experience erosion due to direct precipitation. Forces consistent reworking of slopes and higher maintenance costs.

- Pro: interim cover
- Con: poor compaction on steep slopes

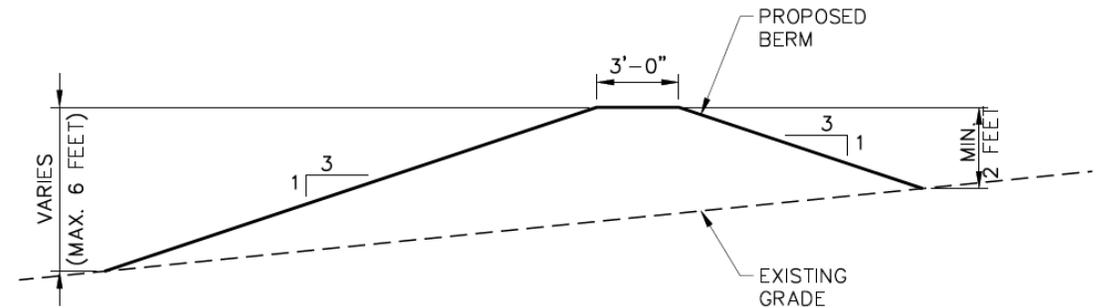
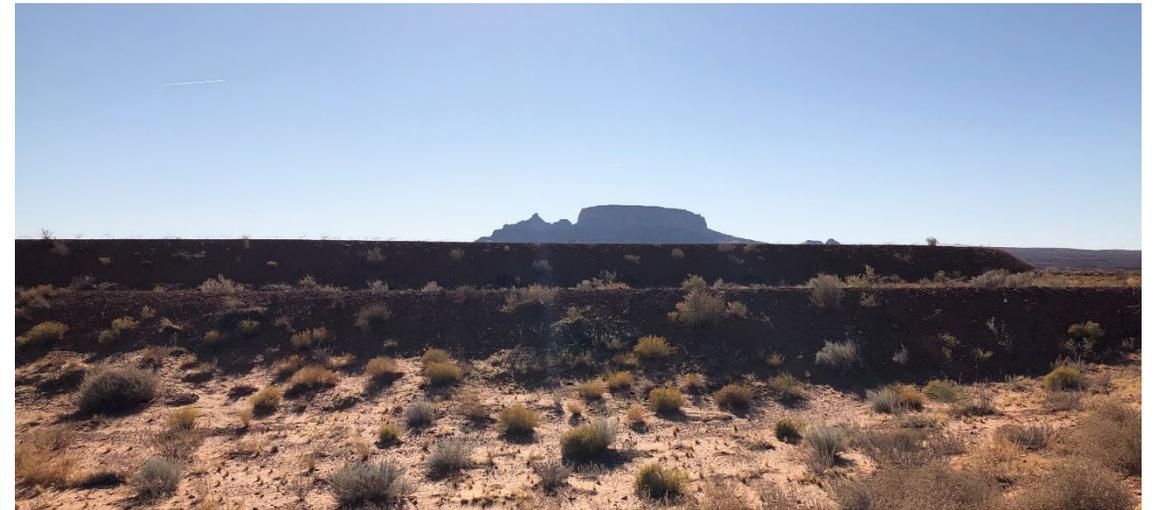
- Lack of stormwater controls offsite to minimize run-on to active portion of landfill. Solution was to add stormwater control berms in prior to closure design.
- Offsite at top of ~100-ft. high vertical sandstone rock
- Approximately 60 berms/evaporation ponds have been constructed
  - Effectively eliminate stormwater run-on
  - Control 25-yr., 24-hr storm event (1.89-in.)

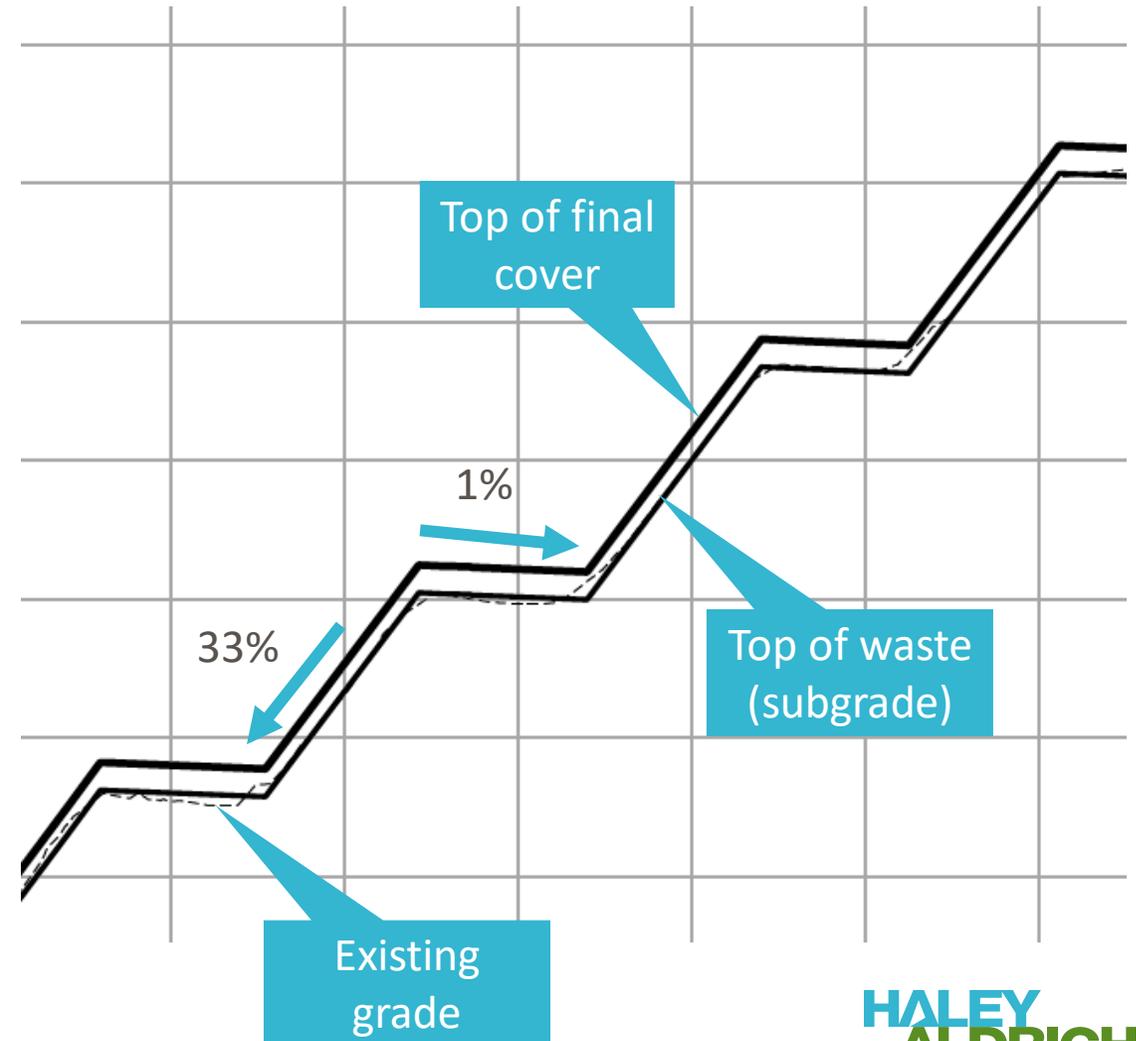
- Geotechnical slope stability models
  - Flattened from 2.5:1 to 3:1
- Material mass balance on existing benches
- Sloped towards “groin” to limit overland flow lengths

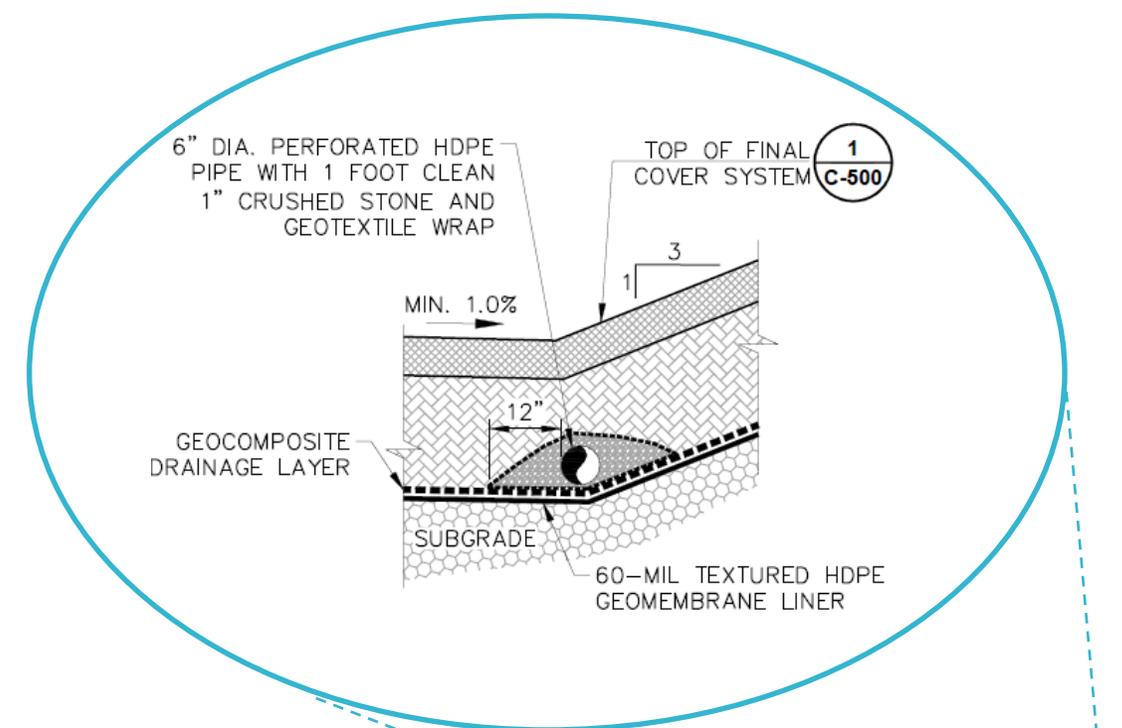
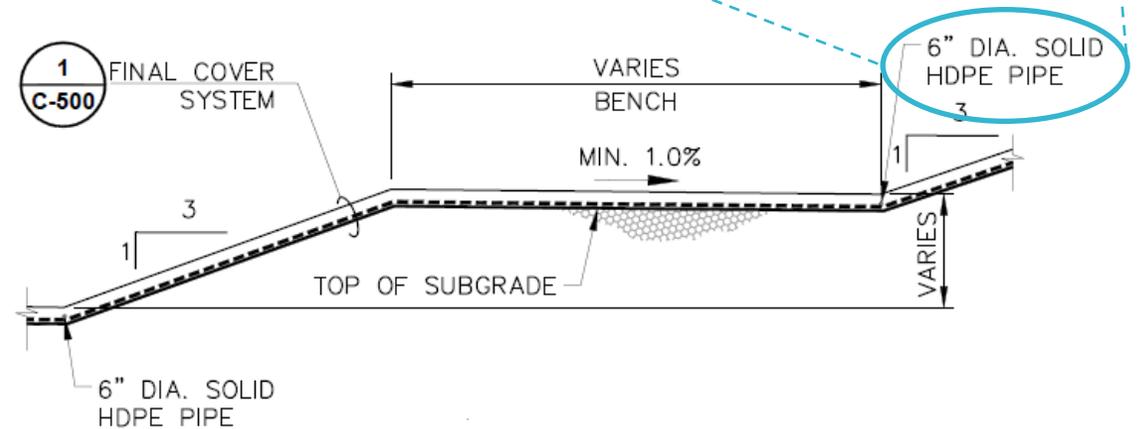
- Overland 1% slope towards groin
- Perforated pipe at groin
  - 0.1% cross-slope towards channels
  - Wrapped in geotextile
  - Surrounded by crushed stone (12-in. thick)
- Geocomposite used to facilitate drainage

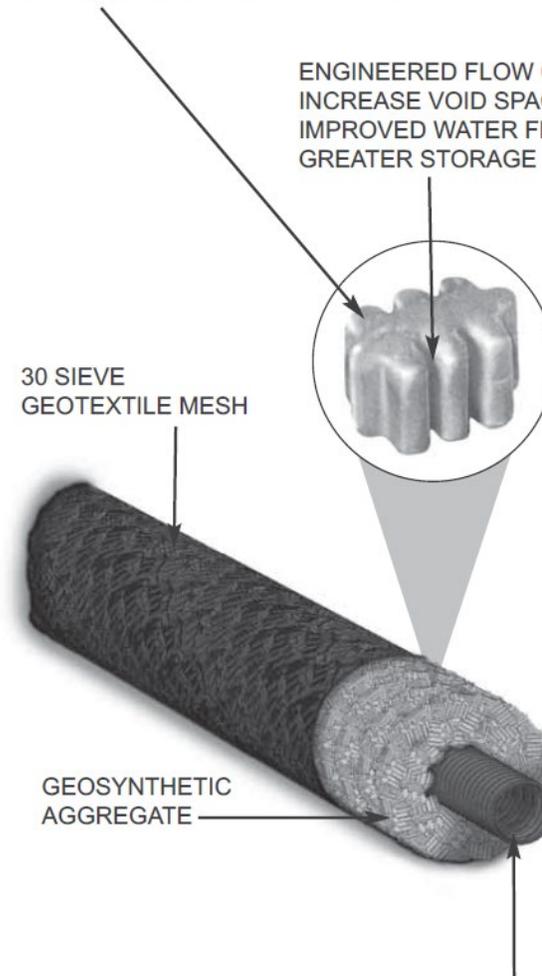
- Perforated pipe alternative
  - Pros
    - Lightweight
    - Cheaper
    - Ease of construction (10-ft. with couples)
    - Can be customized to site
  - Cons
    - Limited soil cover
      - Traffic loadings
      - Exposure during post-closure
      - Potential wind displacement

LIGHTWEIGHT EXPANDED POLYSTYRENE AGGREGATE OFFERS STRUCTURAL INTEGRITY AND RESISTS COMPACTION

ENGINEERED FLOW CHANNELS INCREASE VOID SPACE CREATING IMPROVED WATER FLOW AND GREATER STORAGE

30 SIEVE GEOTEXTILE MESH

GEOSYNTHETIC AGGREGATE

3", 4" OR 6" SLOTTED PIPE

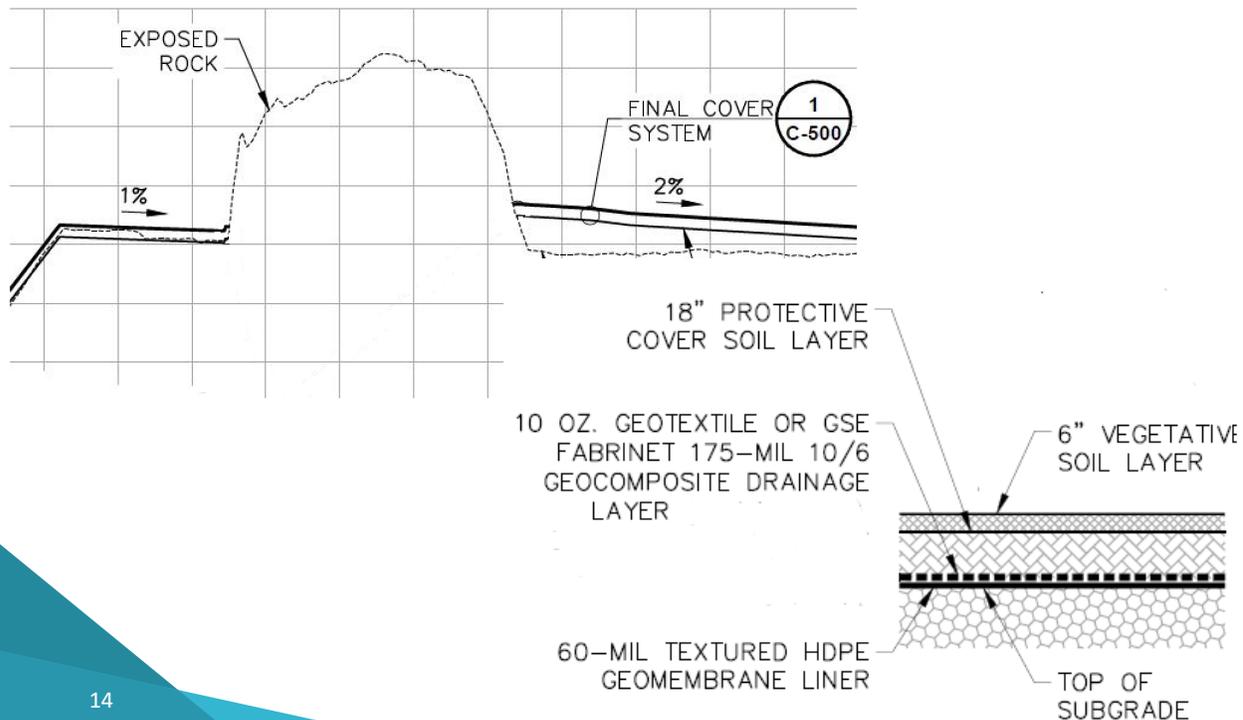
- Limited on-site borrow soil
- Elevated bedrock
  - Borrow
  - Final cover tie-in areas

- Final cover options considered
  - Evapotranspiration final cover system
    - Not enough borrow soil for thick enough cover
  - Soil only final cover system
    - No native clay borrow source
  - ClosureTurf/Lesser soil cover
    - Not viable option through local permitting agency
  - Geomembrane final cover ✓
    - Permeability equivalent to 18-in. soil @  $1 \times 10^{-5}$  cm/sec
    - HDPE chosen over LLDPE due to puncture resistance

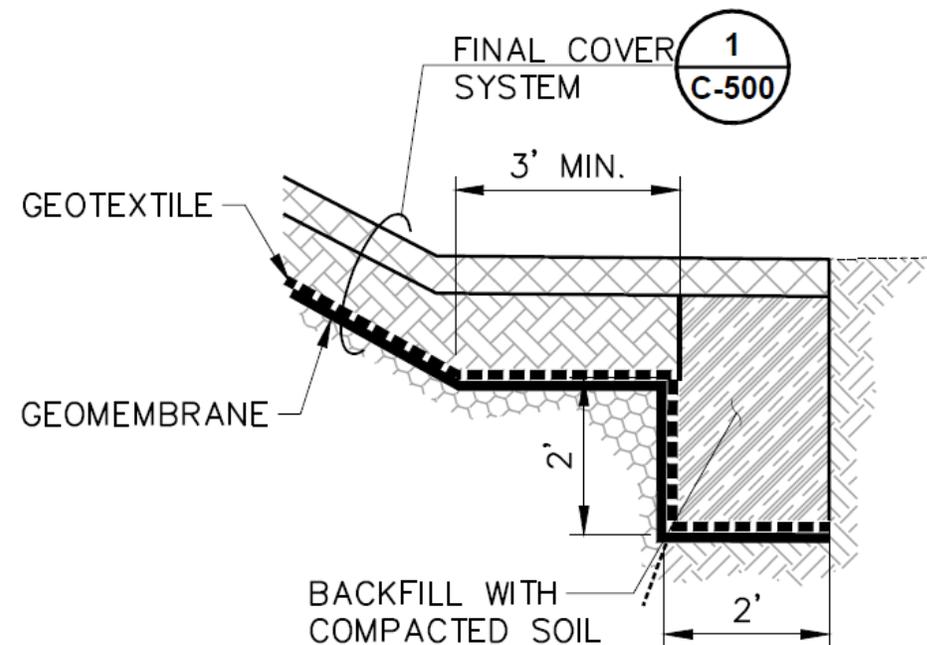
- Borrow sources utilized as stormwater evaporation basins
  - Primary design input was soil borrow volume required
  - No impact to stormwater
    - 6.5-in. annual rainfall
    - 1.55-in. 10-yr., 24-hr. storm
  - Borings and seismic refraction
- Geomembrane anchoring
  - Traditional anchor trench
  - Vertical rock faces...

- Specifications required Contractor alternatives for anchoring
- Anchoring options not considered
  - Running the geomembrane up the slope and anchor to concrete plinth
    - High (~100 vertical ft.) rock faces
    - Geogrid underlying the geomembrane for slope reinforcement
  - Closure by removal along perimeter combined with standard anchor trench
    - Unknown bedrock elevations below grade
    - Cost impacts to inspect clean closed areas
    - Rainfall is directed to anchor trench from vertical rock face
  - Steel batten bars
    - Uneven, porous surface (sandstone vs. limestone)

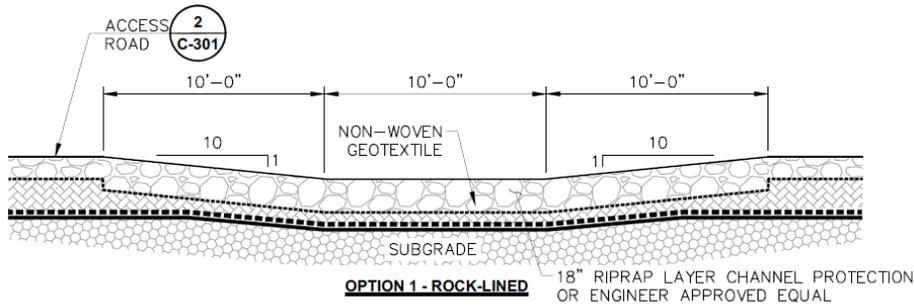
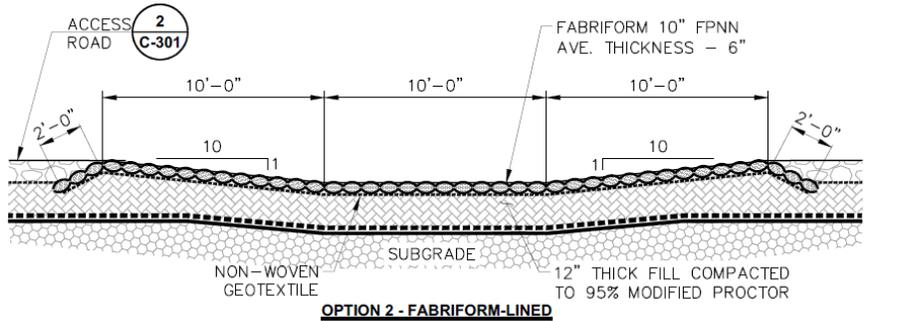
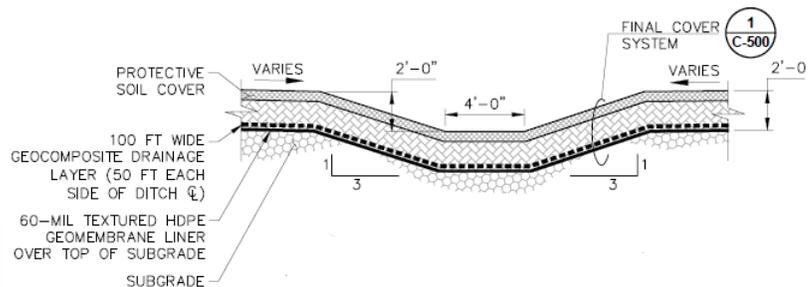
- Access roads for monitoring and inspections
  - Channel/road intersections

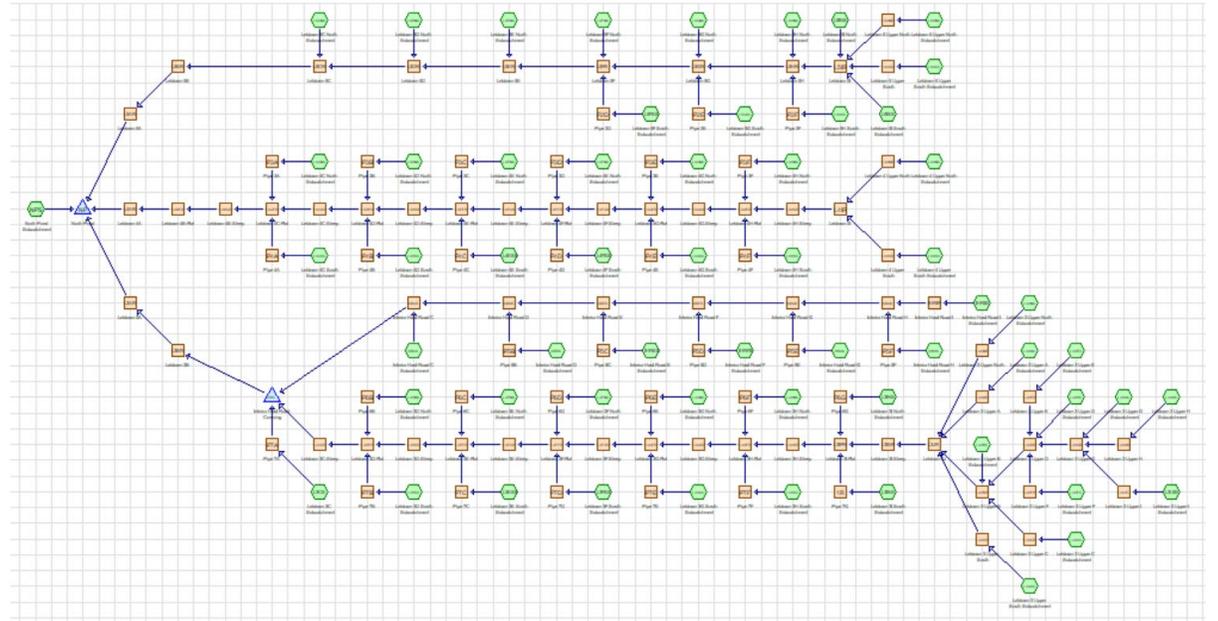
- Erosion
  - HydroCAD
  - Tensar NA Green
