Driven Sheetpile Wall Seepage Barrier Construction in Deep Poned CCR

Zachary K. Williams¹, Ryan T. Smith¹, PE, and Anthony Sak¹, PE

ABSTRACT

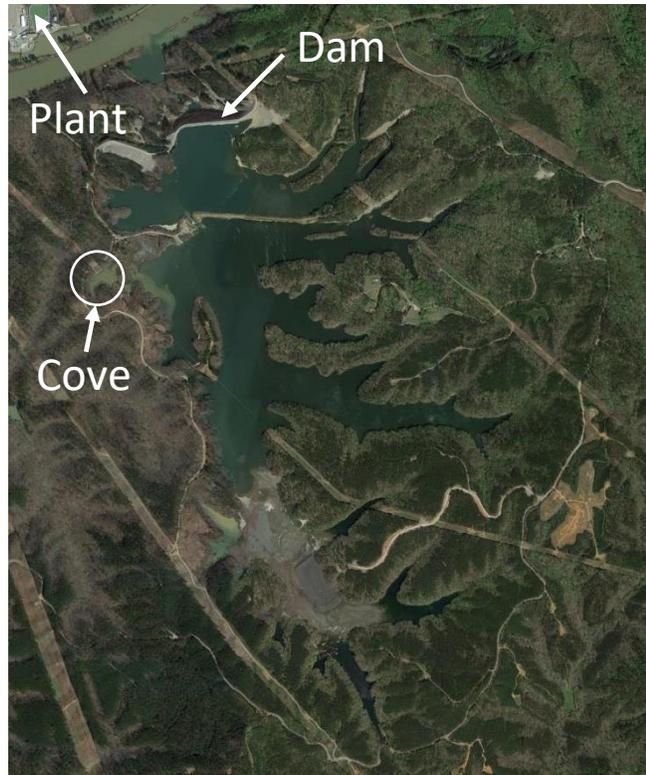
The utility operated a five-unit, coal-fired power plant. CCR was wet sluiced from the plant and across the river to a CCR pond constructed by damming a valley, Figure 1. After multiple raisings, the dam, at the time of closure, held back a pond with a surface area of about 420 acres (170 hectare) containing an estimate twenty-five million cubic yards (19.1 million cubic meters) within a 1,300-acre (526-hectare) watershed. The plant owner dry-stacked a minor amount of CCR material in the upper reach of the CCR pond.

Figure 1. Overhead View of CCR Pond.

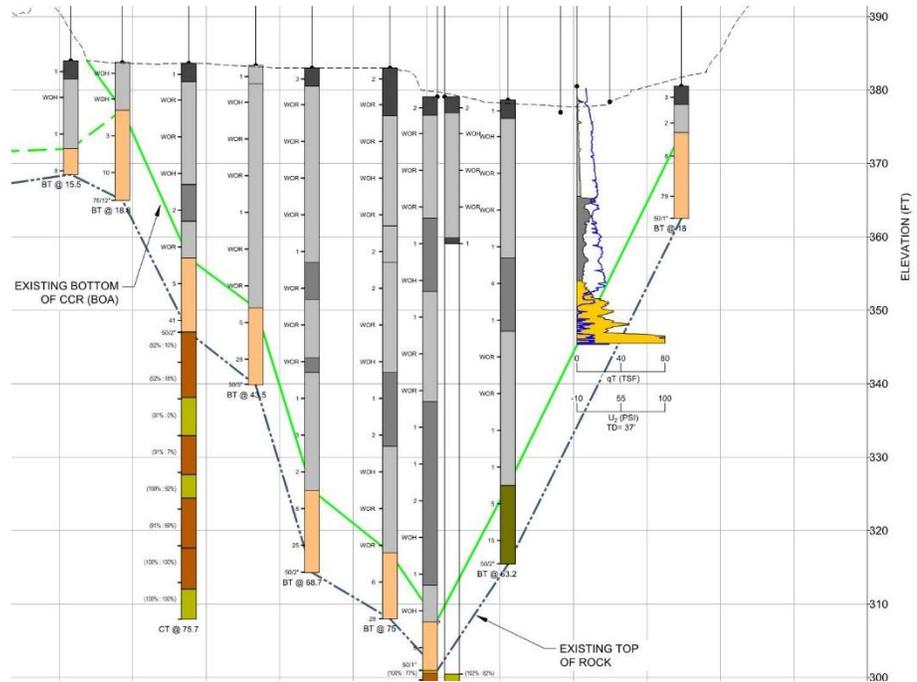
The foundation of the berm and barrier consisted of a variable profile of fly ash, bottom ash, and a mix of both fly/bottom ash, Figure 2. Standard Penetration Test N-values in the CCR profile ranged from weight of rod/hammer to a maximum of two blows per foot (0.3 meters) [bpf], values typical for sluiced CCR. The CCR was underlain by an estimated 10-foot (3-meter) layer of residual soil with SPT N-values of three to greater than 100 bpf underlain by bedrock.

Figure 2. Subsurface Profile along Barrier

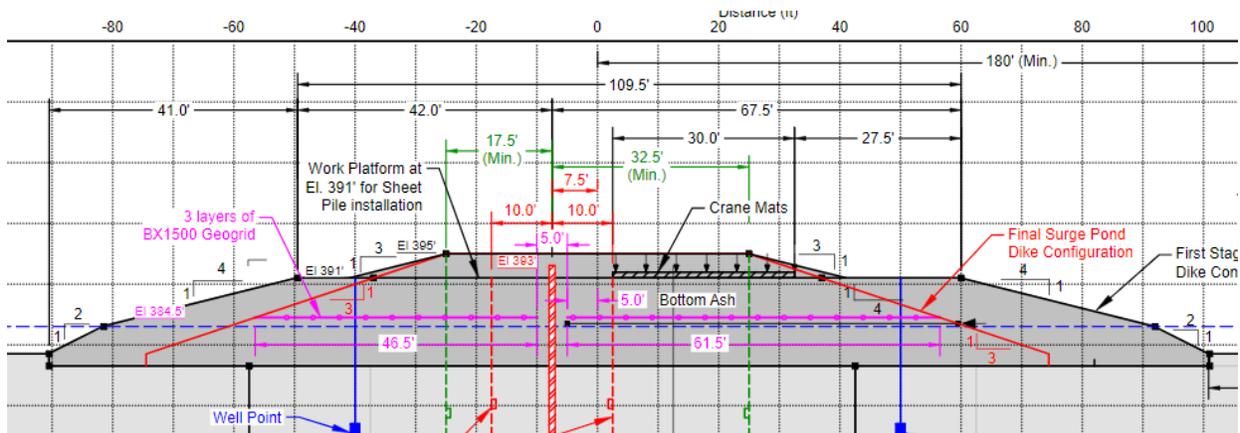
The fill materials consisted of bottom ash obtained from the dry stack area and included three layers of geogrid reinforcement. The design called for bottom ash placed on the existing CCR material up to the grade for three layers of geogrid reinforcement, each layer deployed at 90 degrees to the previous layer. One-eighth inch (3 mm) diameter galvanized wire reinforced the 12-inch (0.3 meter) overlaps. Note the geogrid deployment left a 5-foot (1.5 meter) wide gap centered around the future sheet pile wall alignment.

The berm construction finished at the final grade with a completed crest width of fifty feet (15 meters), Figure 3. A specified rest period allowed dissipation of any excess porewater pressures measured by the geotechnical instrumentation (described later).

Figure 3. Holding Pond Berm Cross Section

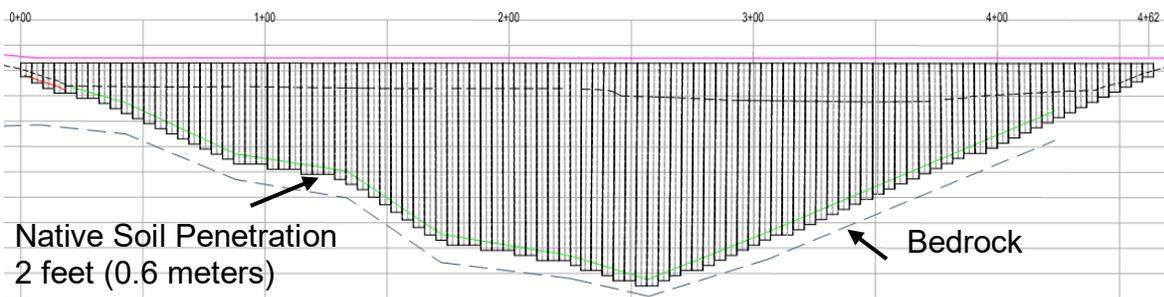
The Engineer selected the alignment and provided the design profile for the barrier wall, see Figure 4. The final design had a total barrier length of 465 feet (141.7 meters) and a 2-foot (0.6-meter) penetration into the residual soil material underlying the CCR.

Figure 4. Design Engineer's Barrier Profile

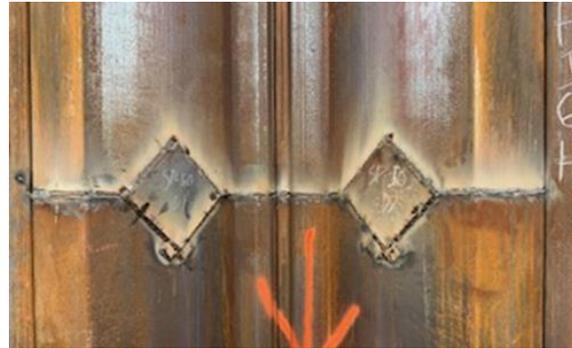
For the middle portion of the barrier Keller drove the first 40-foot (12.2 meter) pile segment just above the work platform then spliced and welded an additional pile segment before driving to final grade, Figure 5.

Figure 5. Face View of a Completed Splice on a Sheetpile Pair.

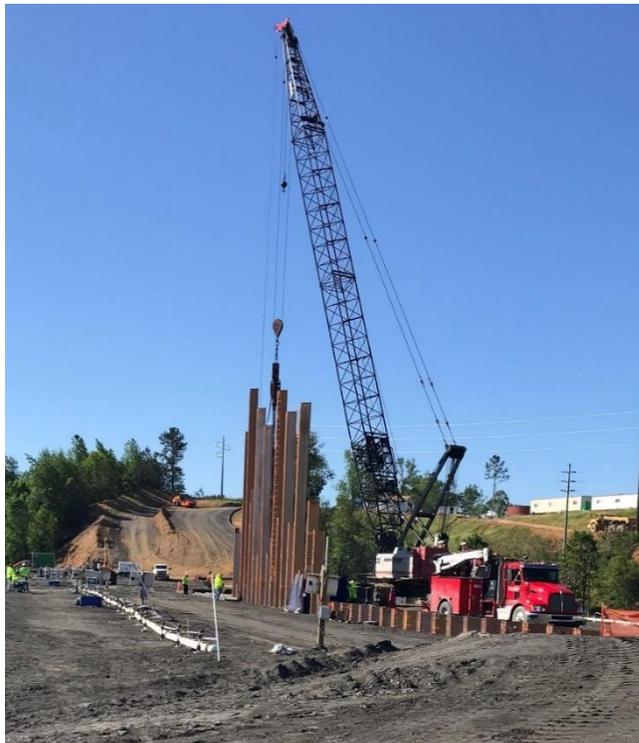
Figure 6. Sheetpile Installation. Note Dewatering Header on the Lower Left Side of the Photo.

Production pile driving proceeded smoothly, Figure 6. However, there were two occasions where the Engineer indicated there were problems. The first was due to what Keller deemed pile refusal but the Engineer felt the interlocks between individual sheets had welded together, inhibiting further driving. The design engineer required that Keller pull these suspect sheets to prove they had not in fact welded together, then redrive them. This work required a separate submission and approval of an extraction work plan. The interlocks had not welded together, and the piles driven again to refusal, to final elevation.

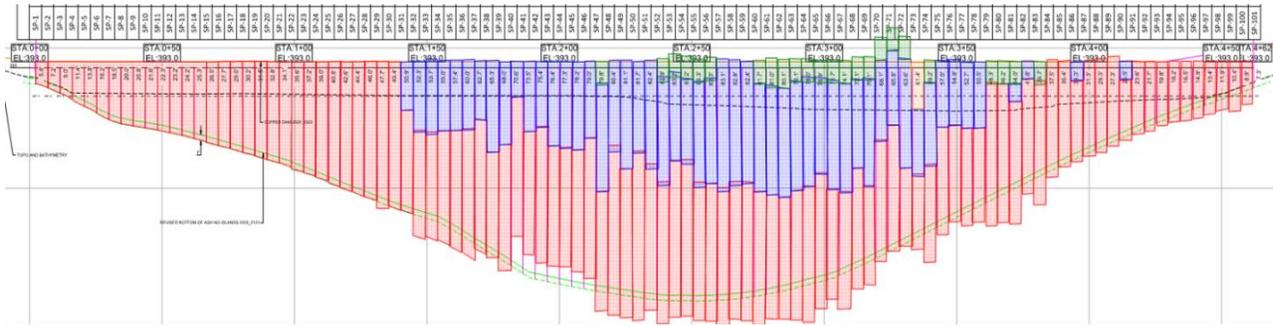
Engineer quickly mobilized a geotechnical exploration rig to the site and proceeded to conduct cone penetration testing (CPT - hydraulically pushing an instrumented cone and connecting rods into the ground at a constant rate) at discrete points along the length of the wall. Keller's crew and equipment were on standby, as the Engineer conducted the testing and evaluated the data. The Engineer concluded over half of the sheet pile pairs

required additional driving, as shown in Figure 7. Many of these piles needed splices added before the additional driving could proceed.

Figure 7. Finished Barrier Profile
