Lessons Learned from 30 Years of Construction Quality Assurance in Geosynthetic Lined Containment Systems

Glen W. Toepfer¹

¹CQA Solutions, Ltd., 723A Phillips Avenue, Toledo, OH 43612

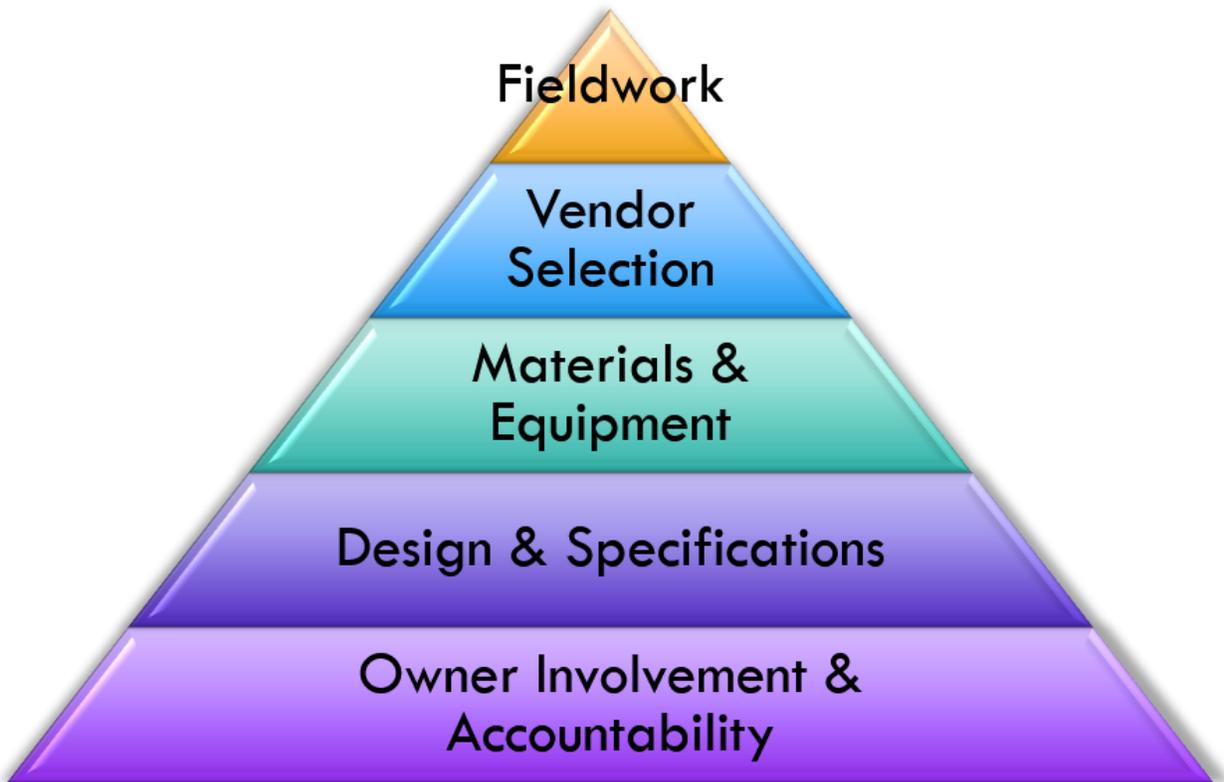
Figure 1. Structure of Quality

The following diagram illustrates the layers required to obtain quality objectives on any project. Each layer builds upon the other layer. The entire project and vision start with the owner who is responsible for holding everyone else accountable to their vision. The project is designed to meet the owners' vision (in accordance with regulations) and project specifications are determined to meet the design objective. The design should also account for proper materials and equipment to be used and purchased followed by the selection of vendors to provide the materials and/or services. Finally, the tip of the pyramid is the fieldwork – the portion of the project where tangible progress can be visually observed.

The aforementioned examples deal primarily with the top of the pyramid in the fieldwork category. But what about other portions of the pyramid leading up to the fieldwork?

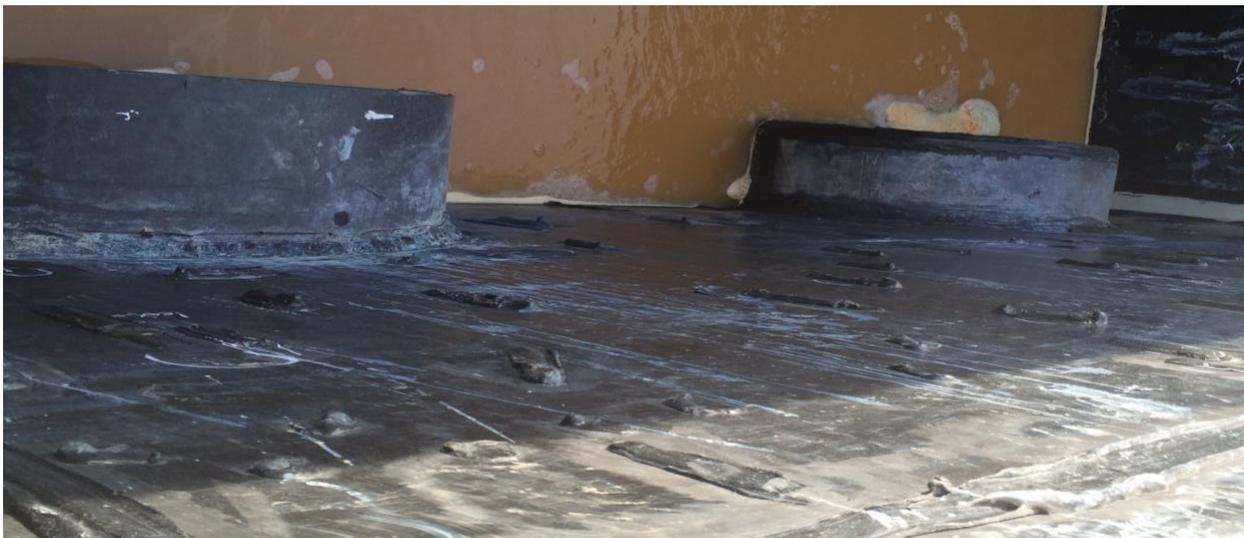
Figure 2. Weir with excessive damages and subsequent repairs.

This photo was taken of looking down inside a weir which was constructed with a stud liner backed geomembrane used to attached the liner to the concrete. The general contractor had never worked with the geomembrane before and asked the design engineer how to secure the geomembrane to the forms. The design engineer stated “nail the shit out of it”, which the contractor complied with, using finishing nails. Everyone was surprised when the weir was put into service and leaked! The extrusion beads shown represent the repairs of the finishing nails, which were found by vacuum testing the entire surface given the finishing nail holes were extremely hard to visually locate.

Another flaw in the design were the weir corners. The contractor tried to extrusion weld the corners in the actual corner whereas a prefabricated corner joint readily available on the market could be used to provide better accessibility and assurance that a higher-quality weld would be obtained on all corners.

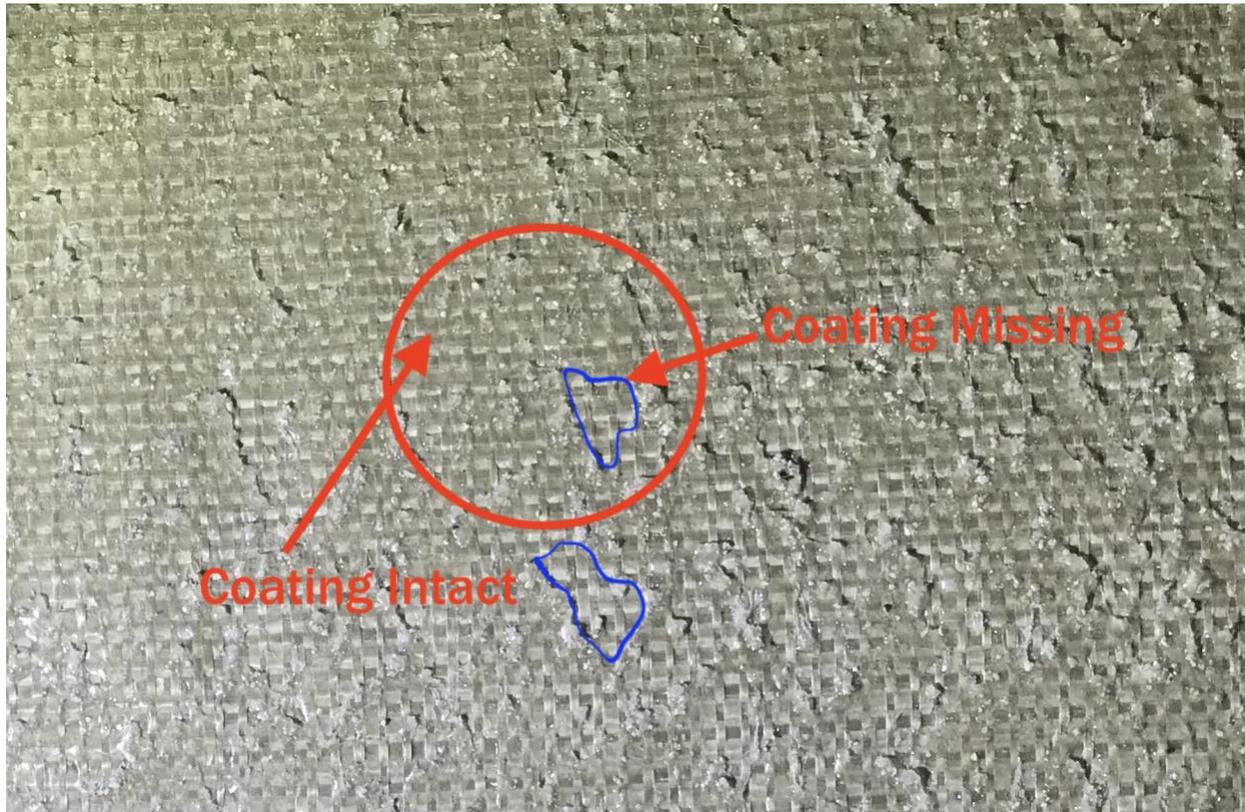
Figure 3. Coating missing from specialty GCL.

First, plant inspections may be warranted for certain materials – in particular, specialty products such as coal-ash resistant GCL's. Figure 3 below illustrates how on this batch of material, the coating separated from the cover geotextile during unrolling because of adhesion to the coating on the carrier geotextile layer. As the roll was unrolled, delamination of the coating occurred as illustrated in the blue areas. The result was a permeability that did not meet the project specification.

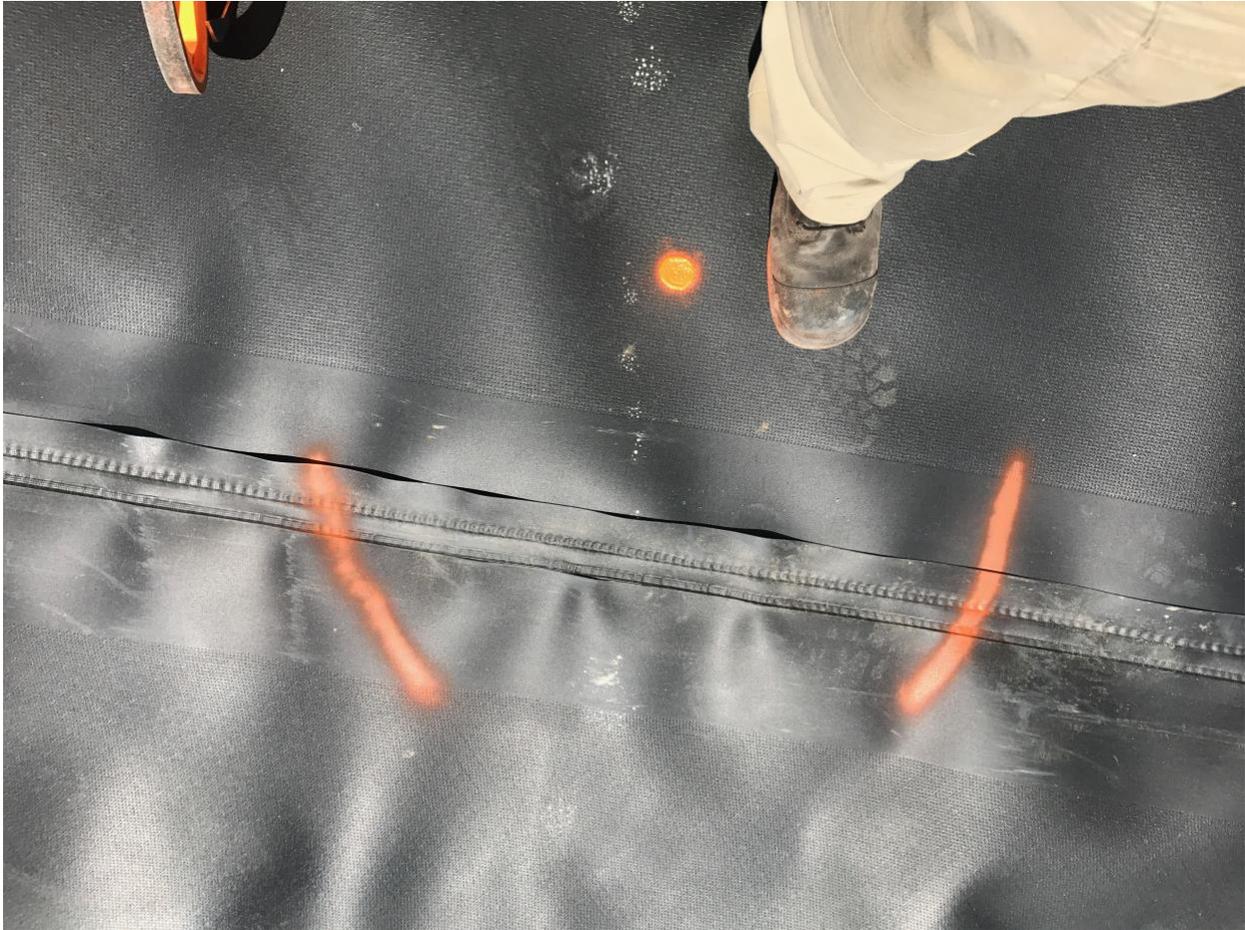
Figure 5. Excessive heat during fusion welding (entire seam, not just marked area).

For any seam to achieve maximum quality, there are three parameters that must be obtained – proper contact time, heat, and pressure during welding. In addition, the seam area must be clean and dry. Today's trend in this regard appears to be towards potential overheating of the geomembrane during seaming as this will help prevent peel failure and still pass shear testing. There is quite a bit of research elsewhere on this topic given by Dr. Kerry Rowe, Dr. Ian Peggs, and others. It is quite possible that geosynthetics installations are reaching the point where testing beyond simple peel and shear tests could be possible to evaluate the impact of such welding. Figure 5 shows excessive heat on a fusion seam and Figure 6 shows excessive heat on an extrusion seam.

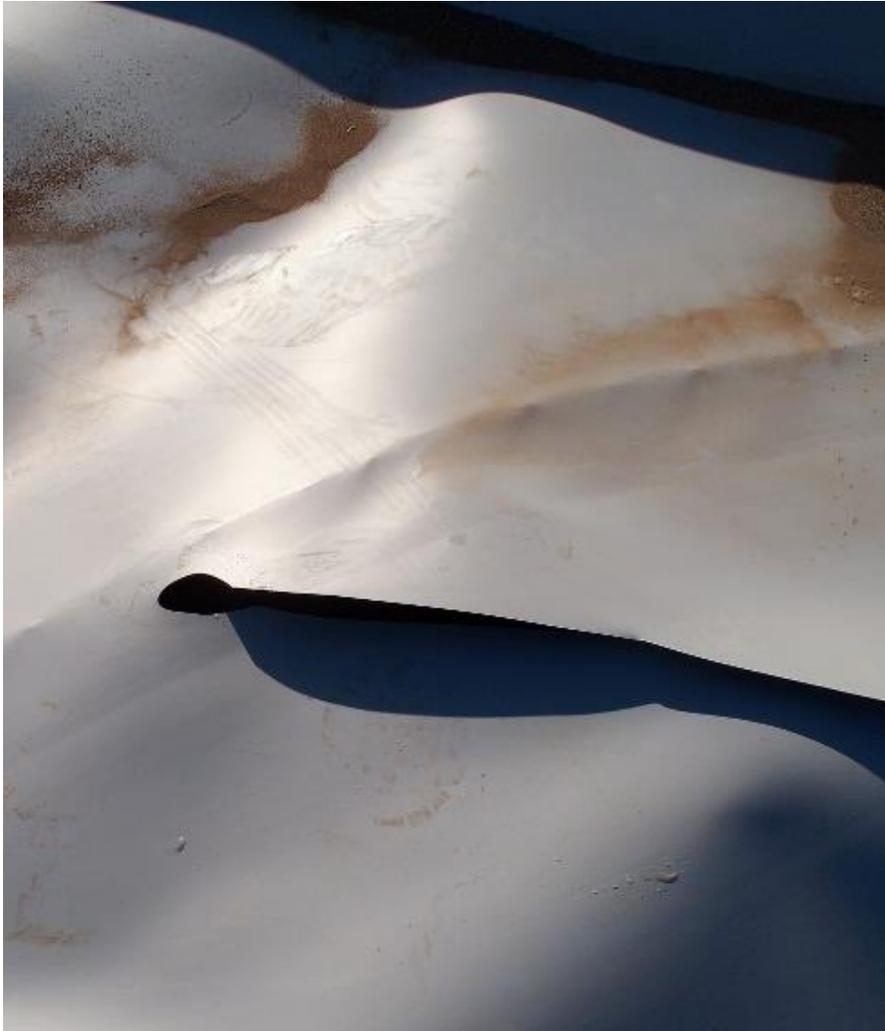
Figure 7. Keyhole termination of straight-line cut.

One best practice that is often neglected is the rounding or termination of straight-line cuts in the geomembrane. There is plenty of research (see Edward Kavazanjian from Arizona State University) in particular that show straight-line cuts will propagate under stress right through (below) an extrusion repair. Rounding of all cuts like the keyhole termination of a wrinkle repair shown below in Figure 7 is a recommendation the author strongly believes will help long-term quality, particularly on projects were stress is likely to be induced into the liner system.
